# **SHEAR REINFORCEMENT IN DEEP SLABS**

Stanley C. Woodson, PhD, PE

US Army Engineer Waterways Experiment Station

13. SUPPLEMENTARY NOTES <b>See also ADM000767. Proceedings of the Twenty-Sixth DoD Explosives Safety Seminar Held in Miami, FL on 16-18 August 1994.</b>

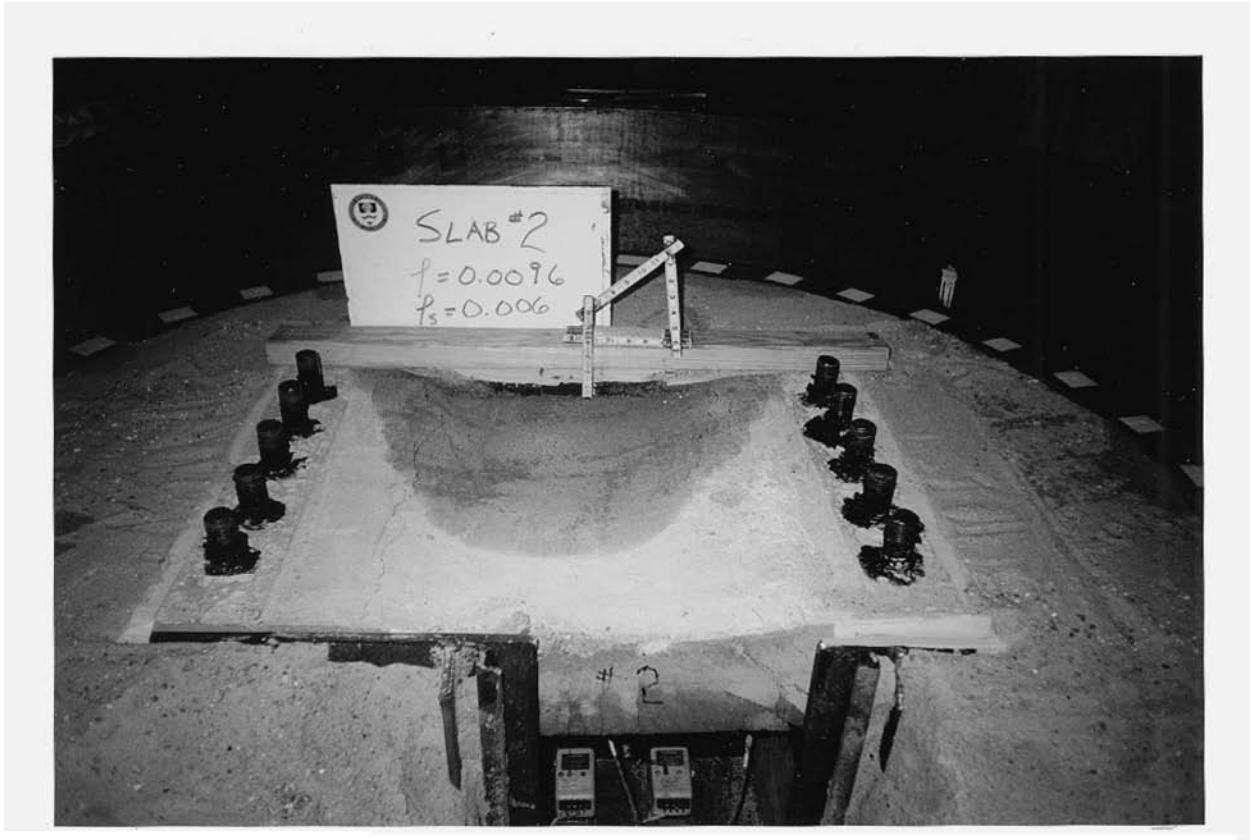
Figure 18. Posttest View of Slab No. 2

Posttest measurements and inspection provided a data check and damage assessment of each slab prior to removal from the reaction structure. Indicating the types of damage incurred in the series, Figures 17 through 20 show the posttest condition of four of the slabs (slabs no. 1, 2, 7, and 13).

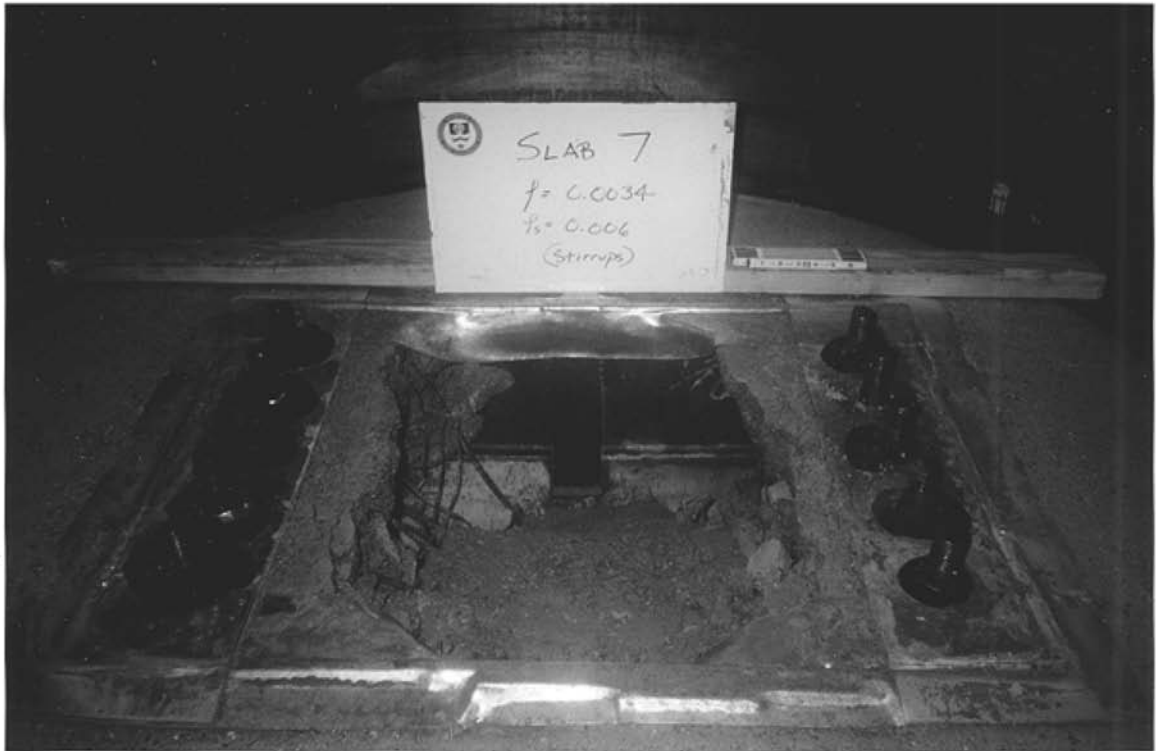
Figure 19. Posttest View of Slab No. 7
